SITE INSPECTION REPORT ON ATLAS ASBESTOS COMPANY COALINGA ASBESTOS COMPANY COALINGA, CALIFORNIA

TDD# F-9-8007-2

#### HAZARDOUS WASTE SITE INSPECTION REPORT

4 December 1980; 1250-1615

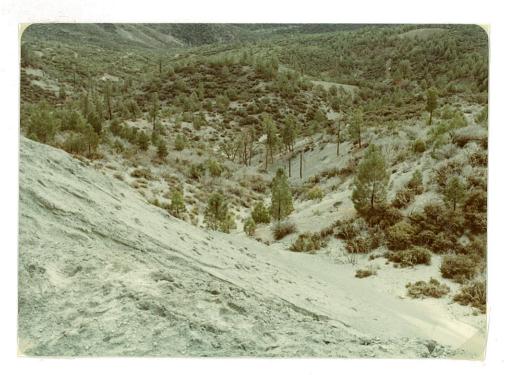
- The site is located in the upper reaches of the watershed and does not appear to be subject to high runoff flows. (Photos #1,3)
- The entire site was wet and gray in color, contrary to the white material observed in current aerial photos.

Photograph #1. DRAINAGE AREA TO THE EAST OF TAILINGS.

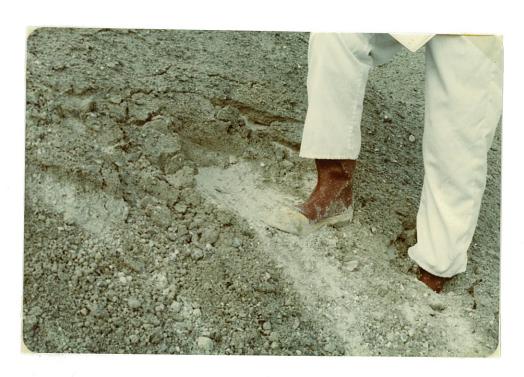
- The tailings were wet to a depth four to six inches beneath the surface. Below this blanket the tailings were dry, white in color and appeared to have the consistency of finely ground fibrous and taic-like material. (Photo #2)

Photograph #2. CONTRAST BETWEEN WET AND DRY TAILINGS.

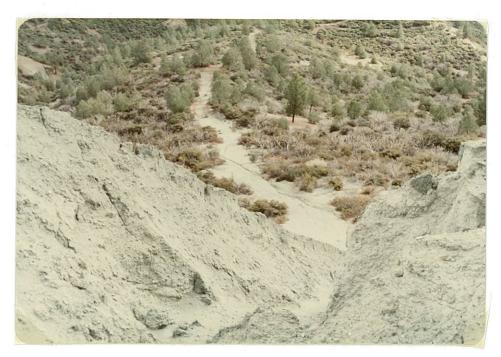
- Several major erosion cuts were noted on the sloped faces of the tailings. (Photo #3)
- Deep fractures (approximately five feet) were noted on the top surface of the tailings.

Photograph #3. EROSION CUT AND DRAINAGE AREA TO THE EAST. EVIDENCE OF SEDIMENTATION.

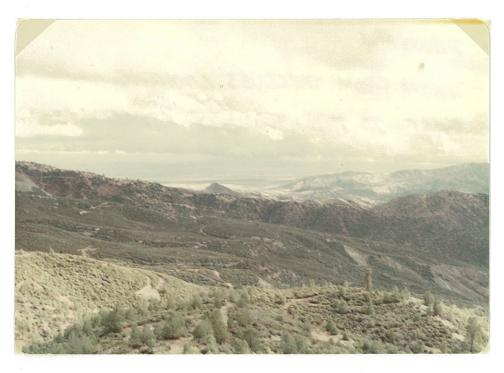
- The town of Coalinga was observed to the southeast through the valley while standing on the tailings. (Photo #4)

Photograph #4. FROM TAILINGS FACING EAST WITH THE TOWN OF OF COALINGA IN THE FAR DISTANCE.

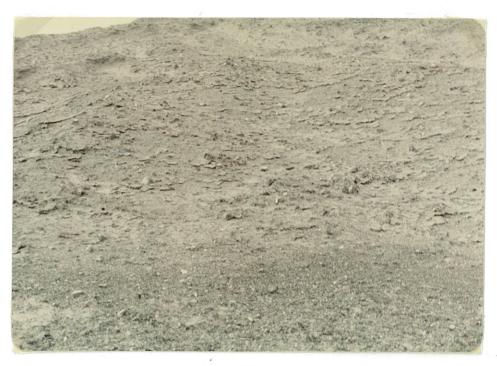
- Any crust that had existed was destroyed by the intensity of the rainfall. On the easterly slopes of the tailings remnants of a thin, fragile crust were noted. (Photo #5)

Photograph #5. CLOSE-UP PHOTO SHOWING REMNANTS OF CRUST MATERIAL. FACING UP SLOPE AND WEST.

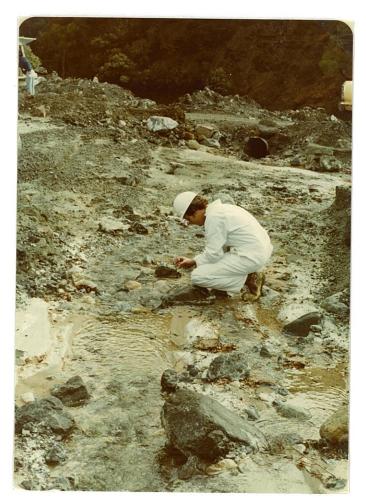
After completing the walk-through inspection, a water sample was taken from an unnamed tributary to White Creek which drains the tailings area (Figure 1). Since no runoff was observed from the tailings the sample is likely to be indicative of natural runoff and erosion of the naturally-occurring serpentine ores. (Appendix B and Photo #6 should be consulted for complete sample documentation.)

Photograph #6. WATER SAMPLE COLLECTION POINT. TAKEN JUST OFF ACCESS ROAD BEFORE CONFLUENCE WITH WHITE CREEK.
